Case 270 : Narrative

Case Vehicle (A): 1999 Ford	Vehicle (B): 1999 Chevrolet	Vehicle (C) : 1990 Chrysler
Type: Escort ZX2, 2-door coupe	Type: Suburban, 4x2	Type: New Yorker Fifth Avenue, 4-door sedan
Driver: 63-year-old male	Driver: 37-year-old female	Driver: 54-year-old female
CDC: 12-FYEW-2, 09-LBEW-4	CDC: 99-0000-0	CDC: 99-0000-0

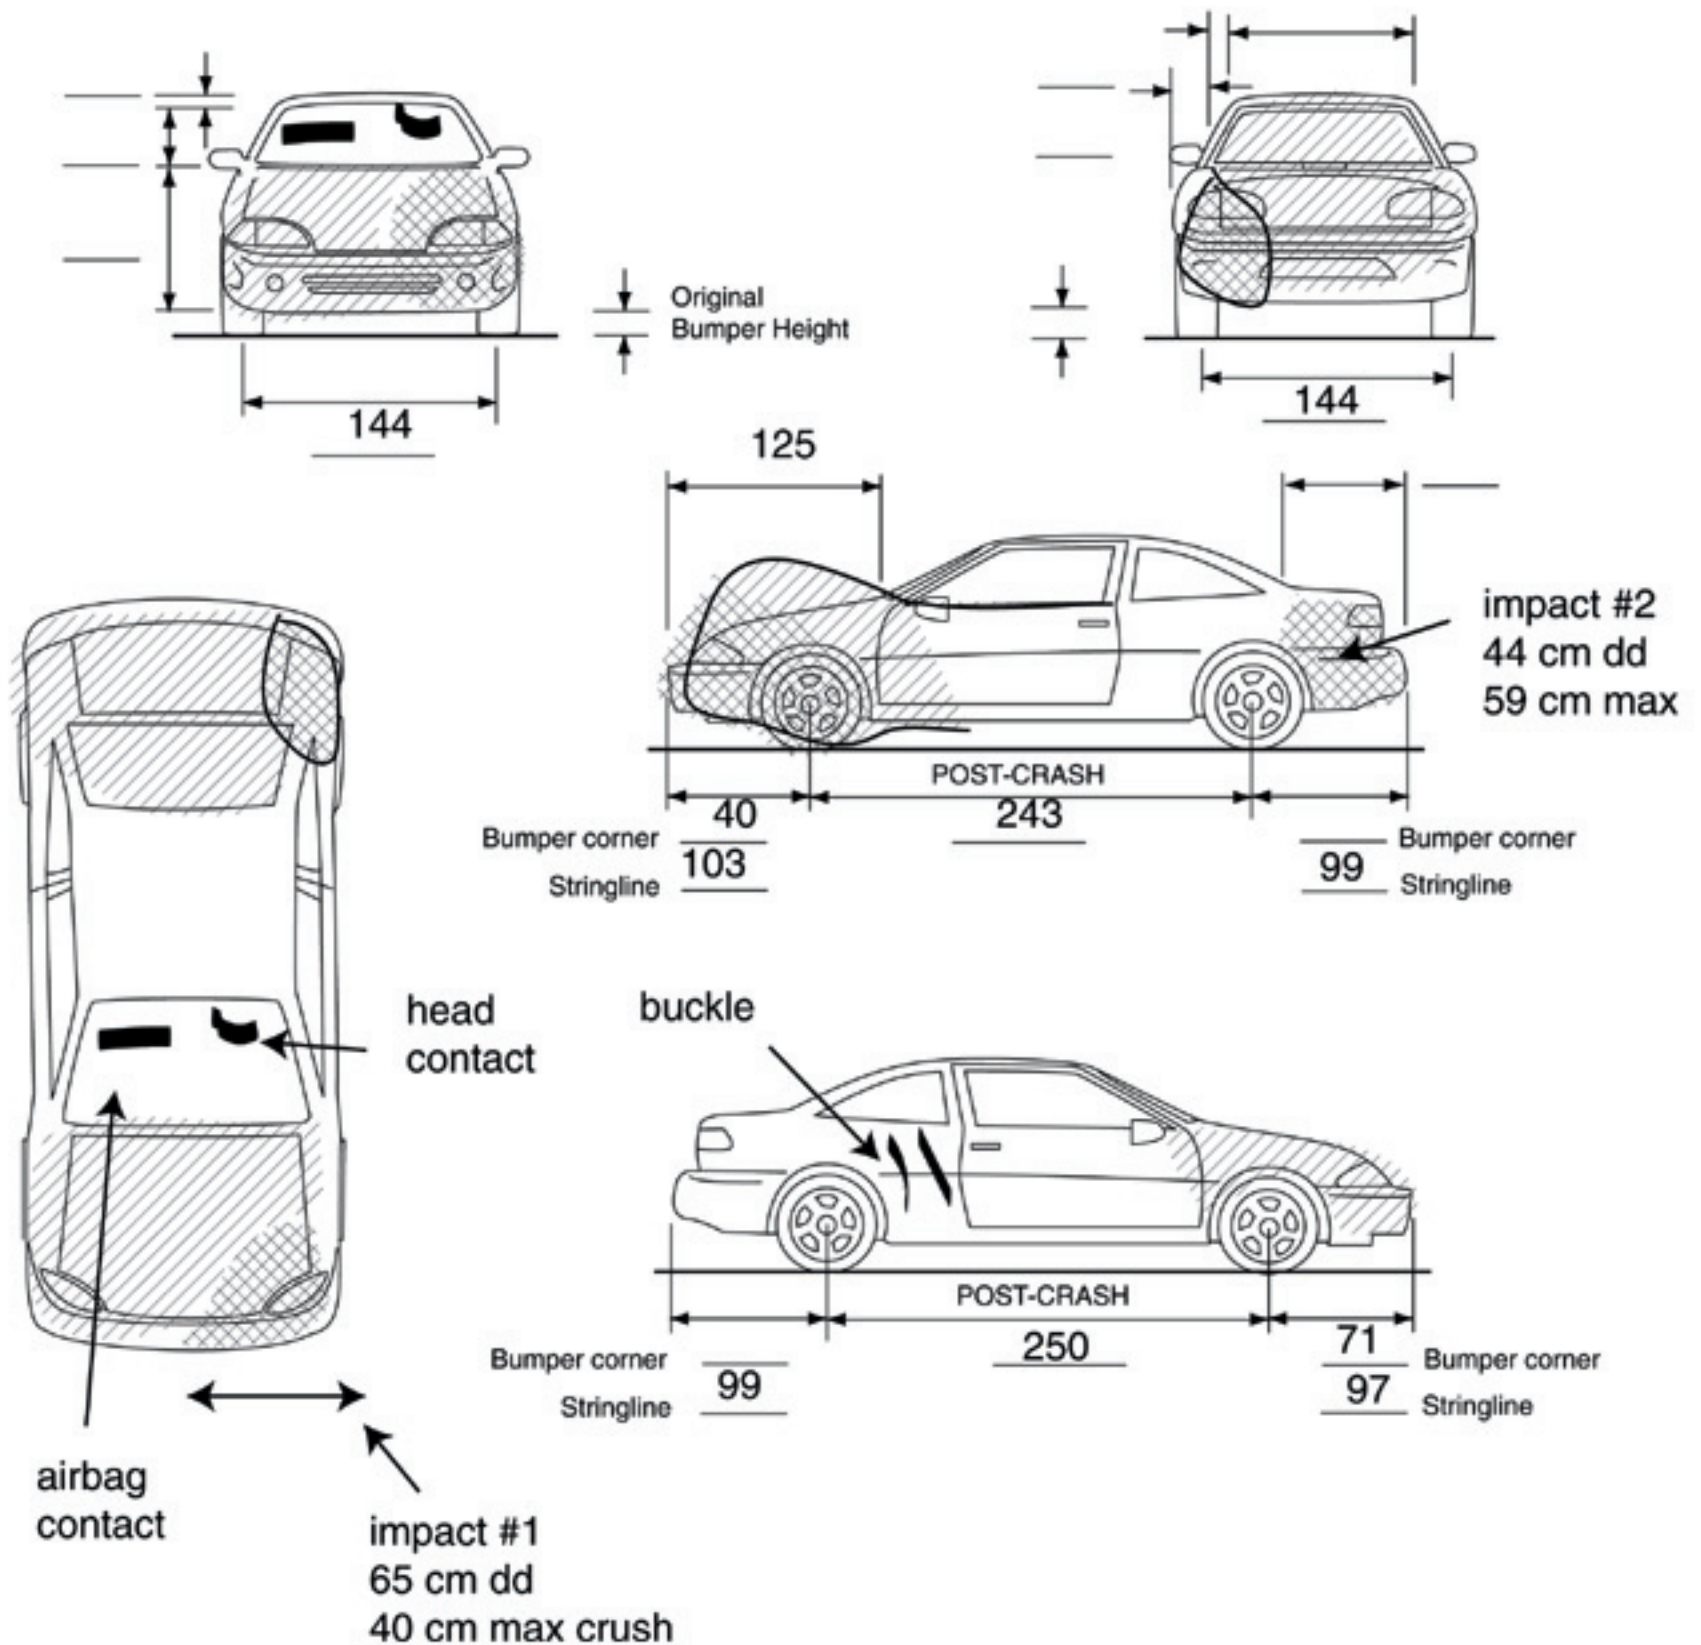
WINDSHIELD MARK ON CASE VEHICLE:

head contact

hair grease

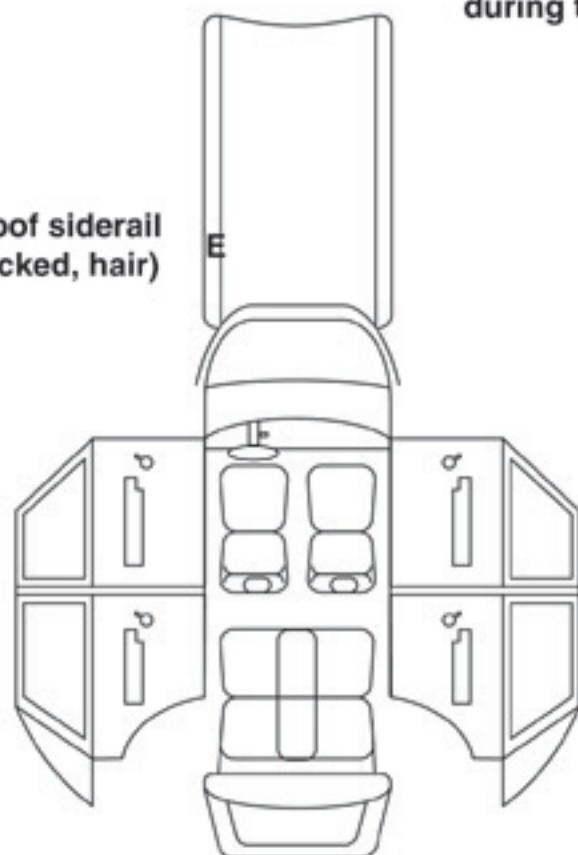
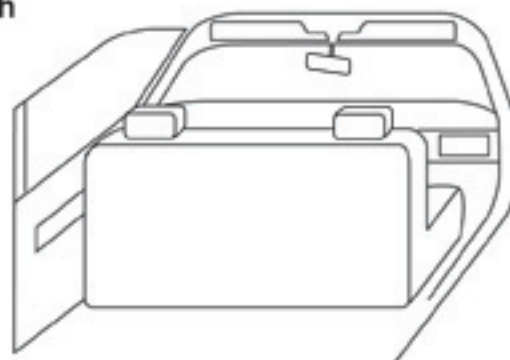
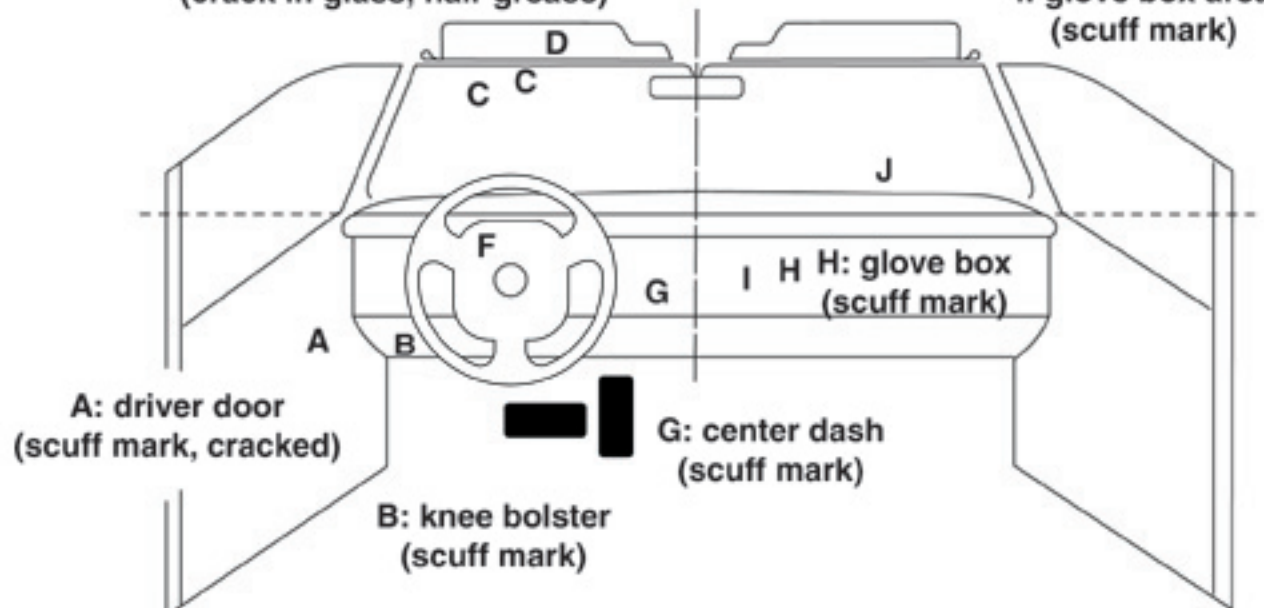
E: roof siderail
(cracked, hair)

F: driver airbag
(black marks)

D: sunvisor
(scuff mark)

C: windshield
(crack in glass, hair grease)

I: glove box area
(scuff mark)

A: driver door
(scuff mark, cracked)

B: knee bolster
(scuff mark)
